Kentucky Camp Chronicle

Newsletter on the gold mining and ranching heritage of Kentucky Camp, AZ

February 2009

Gold Processing Building Discoveries

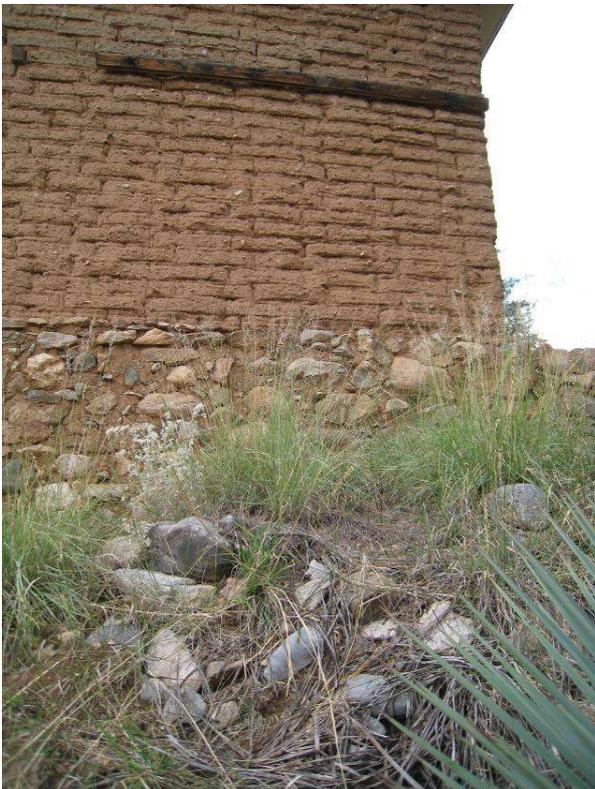
Chemical storage room corner stones and 2 x 4 roof attachment.

During the April, 2008 PITL (PIT-Like Event), I decided to look for the storage addition used for chemicals. My investigation led me to the north side of the building. I have always wondered why there was a 2 x 4 nailed to several "gringo" boards approximately six feet above the floor level but about 10 feet above the sloping hillside and the building's stone foundation. Why would they have gone to so much trouble to have a 2 x 4 that high above grade? Then I noticed a pile of several stones slightly down slope from the building foundation. Taking a closer look, there seemed to be a stone alignment running from the building to this pile and possibly another running to the west toward the Administration Building. This indicated that the pile of stones I first noticed was actually a corner. Being filled with excitement, I whipped-out my tape measure. Since the stones had been exposed to over 100 years of weather and people activity, they were slightly disarrayed and

no longer formed a perfect room alignment. Therefore, I had to use some judgment as to where the vertical corner had been located. Since I did not do any excavation or probing for a west wall which would have attached at the base of the foundation, I assumed that the storage room would have been flush to the west wall of the building. Yes, believe it or not, it measured 5 x 8 feet. It now all made sense. The 2 x 4 high on the wall would have been where the storage room roof attached to the building. The wall alignments would have been constructed to equal the height of the building foundation and a wooden floor would have been built for the storage room.

It will be important for someone with extensive wall alignment excavation experience to confirm the actual foundation alignment. I think we should try to recover stones that once were part of this foundation that have fallen down slope. The stones recovered could then be used to reconstruct a portion of the foundation. This would make it possible for visitors to learn about the chemical storage facility and understand the 2 x 4 roof attachment on the north side of the building.

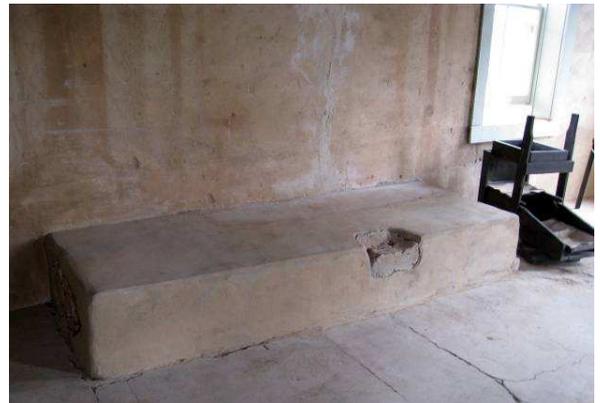
Concrete feature with two pipes at edge of the platform.

Another interesting discovery in the Gold Processing Building made during the April 2008 PITLE involved the two little pipe openings located in the concrete feature on the edge of the platform. The two pipes had openings with different inside diameters. In my documentation report, I had made the assumption that the pipe to the left extended through the wall into the small room. It and the pipe protruding from the wall in the small room had the same inside diameter. Where the right side pipe **went** remained a mystery.

Doug Maus decided to solve the mystery. He wanted to determine if both pipes were connected to the pipe in the small room. He patiently dripped water into the dirt plugged pipe openings hoping to soften the contents and open the pipes. Later, John Weiss was able to attach a "can of air" to the pipe in the small room. The air flow forced muddy water from both pipe openings. The mystery was solved. Even though the two pipes had different sized openings, they were both connected to the pipe extending through the wall. What we don't know is if they are connected by a "Y" or a "T" connector. Without some sort of x-ray equipment we most likely will never know which one.
