# **PIT 2001 A Major Success!**

## **FRESCO FINISHES MINI-P.I.T.**

**KENTUCKY CAMP  
JULY 9-13, 2001**

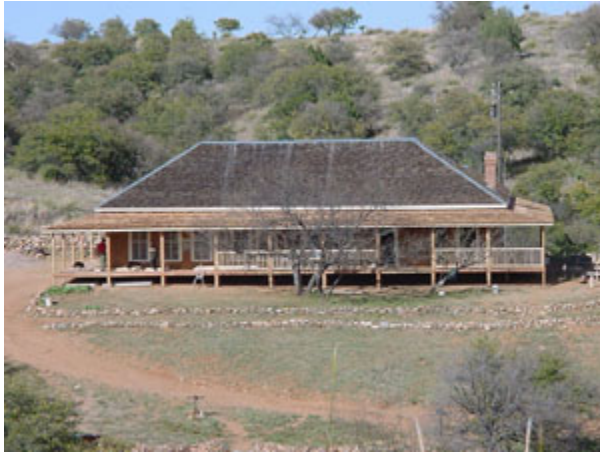
Headquarters Building with its new porch.

The most noticeable and dramatic change to Kentucky Camp is the addition of a porch on the Headquarters building. The porch wraps around the east, south and west faces of the building and makes it a more complete structure. The porch brings out the character of the building, adding depth to the facade, making what seemed to be a two dimensional flat-walled building into a three dimensional structure.

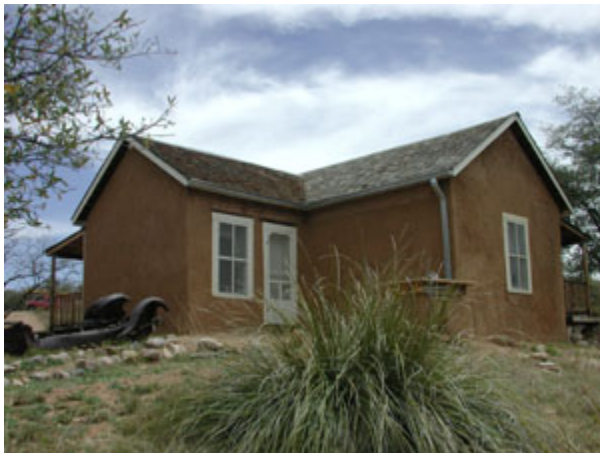
The outside walls of the Cabin are now beautifully finished.

Master mudder Jim Britton ably led the mud crew. The crew built up and smoothed out the outside walls on the south and west sides of the Cabin. Gone are the rows of stones embedded in the adobe; no more sunken and eroded sacrificial wall, the finish is as smooth as the fine-grained interior walls and the building corners are sharp.

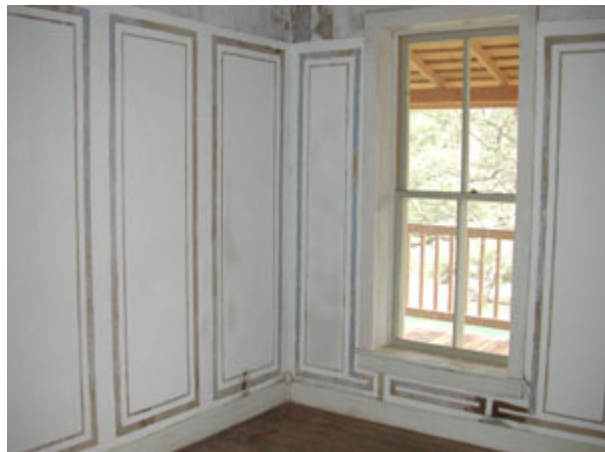
"Blue room" walls after the 2001 Mini-PIT

There were many small holes remaining in the walls that they had not filled in the June 2000 work session. Our first task, this week, was to repair all remaining wall damage. Rodolfo mixed a batch of fine lime mud. This consisted of 5 parts window screened dirt, 3 parts #60 silver sand, and lime solution. The lime solution consisted of lime paste from Mexico and water. This fine plaster formula, except for the lime, is the same as Clint and I had used in Cabin C and in Room #2 of this building. It provides a nice smooth surface and does not crack. The mud was applied with either a flat-nosed trowel or a small paint spatula in a manner that left the mud very smooth and flush with the original wall surface.

Based on wall tests made by Rodolfo, it was decided to use Type S lime purchased in Tucson instead of the Mexican lime solution. Type S dried a bright white and after setting overnight had a nice smooth consistency, which Rodolfo liked. A portion of the lime solution was poured into a second bucket and was thinned by adding water. A very small amount of Elmer's Wood Glue was added as a bonding agent. Three coats of whitewash were applied to all design panels. The first coat was allowed to dry overnight and was mixed slightly thinner than the second and third coats. Once the third coat dried, the white portions of the designs were very white and made the rectangle patterns stand out. It looked great, we were very pleased with the results of our work.

Rodolfo asked us to apply one coat of lime whitewash to the area between the blue rectangle design panels and the ceiling. Paint was applied to new plaster only, never over any original paint. Even though this area had a light blue background and no white, he wanted to seal and cover the dark brown mud plaster that had been used in this area. The room floor was cleaned and the window and door frames were washed with a wet rag to remove all mud. Even though there is a lot more painting to do in this room, our "After" version sure looks great when compared to the "Before". All participants posed in front of these walls for the official P.I.T. photo.

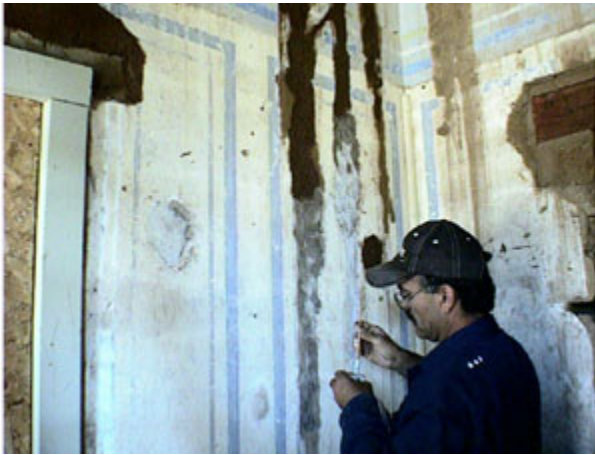
To compare, these are the blue room walls at 1999 PIT

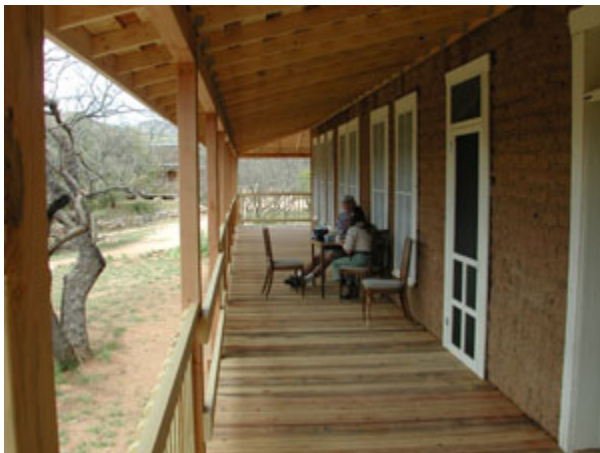
Headquarters Building porch.
